Subject: Weekly Monitoring Report for Week Ending 11/23/2019

Florence Copper, Production Test Facility

Aquifer Protection Permit No. 106360, LTF 61845

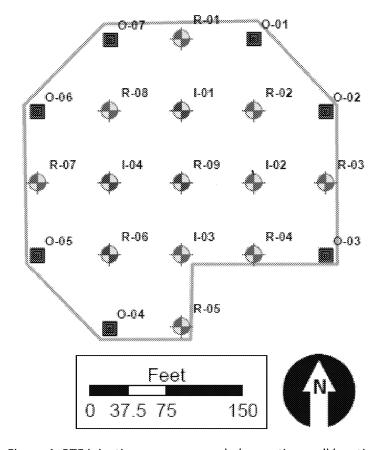
Figure 1. PTF injection, recovery, and observation well locations

A map showing the location of the PTF injection, recovery, and observation wells is included as Figure 1.

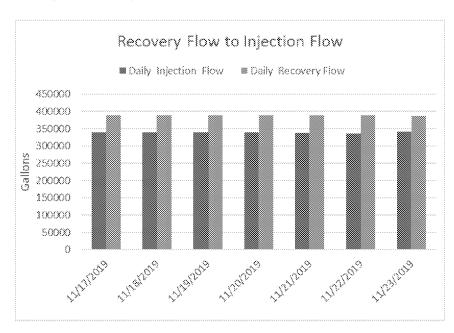
Figure 2. Recovered volume to injected volume

A summary of the injected and recovered volumes for the week of 11/17/2019 to 11/23/2019 is included in Table 1. The total injected and recovered volumes for the PTF as a daily total are also presented on Figure 2.

During the reporting period no exceedance of the alert level was measured for recovered volume to injected volume. The alert level is the recovered volume shall exceed the injected volume.

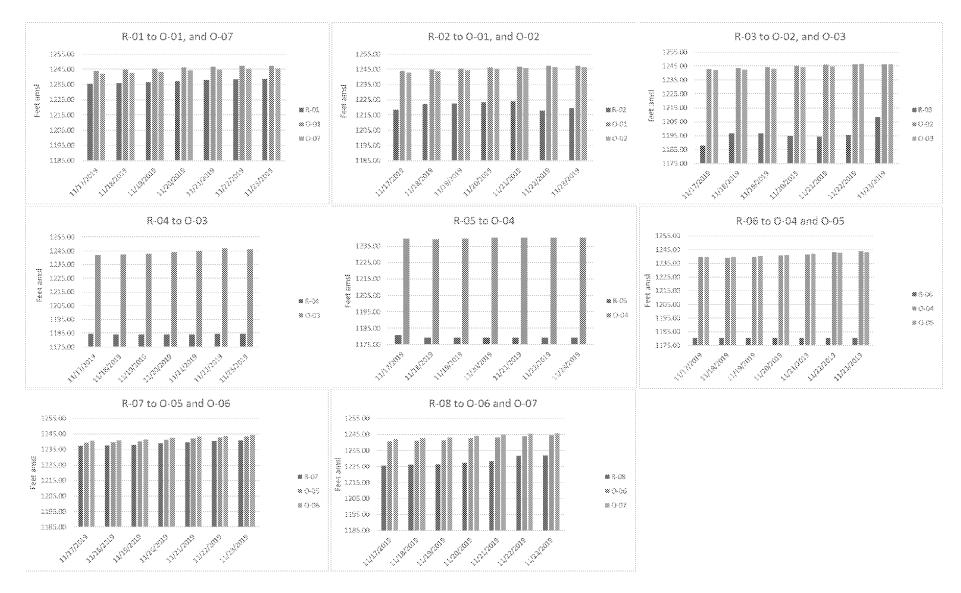
Figure 3. Recovery and observation well pairs

Table 2 includes a summary of water levels in the recovery and observation well pairs. Hydrographs showing the water level elevation for each recovery well and observation well pair are included in Figure 3.

During the reporting period, there was no exceedance of the alert level for the inward hydraulic gradient. The alert level for the inward hydraulic gradient is that the water level elevation in the paired observation well must be a minimum of 1 foot higher than the paired recovery well.
